# EVALUATION OF HOT CORROSION BEHAVIOR OF THERMAL BARRIER COATINGS

P.E. Hodge, R.A. Miller, and M.A. Gedwill National Aeronautics and Space Administration Lewis Research Center

Work performed for U.S. DEPARTMENT OF ENERGY Energy Technology Fossil Fuel Utilization Division

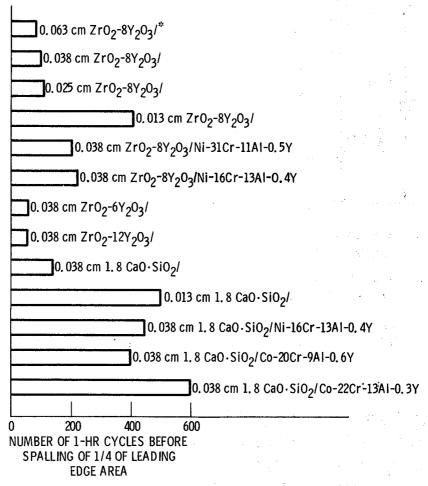
Test results. - The response of the TBCs to the Na plus V doped Mach 0.3 combustion gases is summarized in figure 1. In general the data show (1) that the durability of TBC systems may be substantially improved by reducing the thickness of the TBC from 0.038 to 0.013 cm, (2) that high Cr+Al bond coatings improve the durability of TBC systems, (3) that 1.8 CaO SiO2 coatings are more durable than ZrO2-8Y2O3 at comparable ceramic thicknesses with the same bond coatings, and (4)  $that ZrO_2-12Y_2O_3$  and  $ZrO_2-6Y_2O_3$  TBCs are less durable than ZrO<sub>2</sub>-8Y<sub>2</sub>O<sub>3</sub> TBCs when evaluated with the same baseline bond coating. Specimens with 0.013 cm thick ceramic coatings have higher bond coat and lower ceramic surface temperatures compared to specimens with 0.038 cm thick ceramic coatings. If the temperatures within the ceramic coating or at the bond coat/ceramic interface are higher than the dew points of the condensates (e.g., 905° C for Na<sub>2</sub>SO<sub>4</sub>) no condensation can occur at this location which may account for the increased durability of TBC systems with thinner ceramic coatings. No apparent hot corrosion of the bond coatings was evident from metallographic examination of the tested specimens. The improved durability of TBC systems with various bond coatings thus may not be due to differences in bond coat hot corrosion resistance.

Figure 1. - Mach 0.3 burner rig corrosion test: fuel impurity level, 5 ppm Na + 2 ppm V; fuel/air = 0.046; ceramic surface temperature, 982°C; substrate temperature, 843°C.

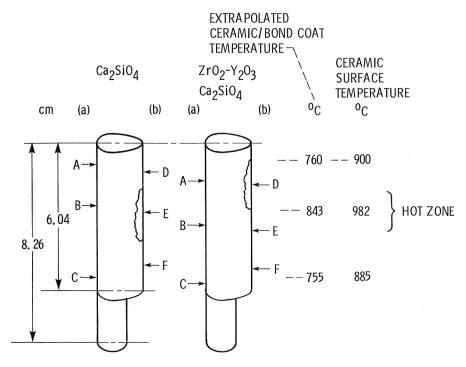
Analyses of test specimens. - Two modes of spalling of the TBCs were observed for specimens exposed in these hot corrosion tests. 1.8 CaO SiO<sub>2</sub> coated specimens spalled in the center of the hot zone. In a few cases, as with YSZ coated specimens, they failed at the upper edge of the hot zone as illustrated in figure 2. Points A, B, and C in figure 2 show where crosssections were taken for metallographic and EMP analyses and points D, E, and F show where samples were taken for SEM/EDAX, chemical, and XRD analyses.

The spalling behavior of calcium silicate is complicated. Most calcium silicate coated specimens spalled in the hot zone. Failure in the hot zone is believed to be due to a gas-phase temperature-dependent reaction of SO<sub>2</sub> with calcium silicate to form CaSO<sub>4</sub>. Based on EMP data, spallation of a few cal-

cium silicate coatings at the edge of the hot zone appears to be due to penetration of  $Na_2SO_4$ ,  $Na_2V_2O_6$ , and Co containing condensates. Further exposure studies followed by analyses will be needed to clarify the mechanism of calcium silicate coating spallation and determine how the phase change of  $\beta$ -Ca<sub>2</sub>SiO<sub>4</sub> (larnite) to CaSiO<sub>3</sub> (wollastonite) affects this mechanism.

Figure 2. - Typical failure pattern of thermal barrier coatings after exposure to Mach 0.3 Na plus V doped combustion gases.

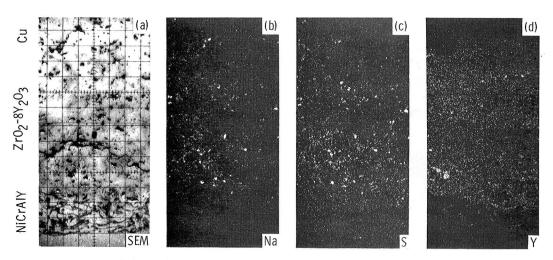
The results of EMP mapping studies of exposed ZrO2-8Y2O3 and calcium silicate coated specimens were in general agreement with the XRD, chemical and SEM/EDAX analyses. In figure 3(a) there is good correspondence between Na and S in a ZrO2-8Y2O3 coated specimen and this is taken as evidence that Na2SO4 formed in the flame and condensed in coating pores and cracks. The scans of V (not shown) and Y indicated local concentrations of Y and some correspondence with V in some of these areas (probably YVO4). Additional EMP scans on the same specimen at the colder A and C sections show some correspondence between Na, S, and Y and between S and Y which is believed to be the possible formation of Y2 (SO4)3 or Y2S3. EMP scans of Ca, Si, S, Na, V, Co, and W in a typical calcium silicate specimen at the A section show several interesting features (fig. 3(b)). This specimen had spalled in the hot zone as indicated in figure 2. There is almost a 1:1 correspondence of Na and S indicating Na<sub>2</sub>SO<sub>4</sub> formation and some V and Na overlap at the surface which is probably Na<sub>2</sub>V<sub>2</sub>O<sub>6</sub>. Of the elements evolving from the L-605 nozzle, only Co penetrated calcium silicate to any extent. Additional S in the interior of the coating is taken as an indication of CaSO4 formation below the surface. EMP scans of the B section of the same specimen in the hotter spalled area show S (CaSO4 from SO2 reaction with 1.8 CaO SiO<sub>2</sub>) and very little if any Na within the entire 0.005 to 0.013 cm remaining coating. However, the bulk of the coating was still calcium silicate based on the EMP scans of Si, Ca, and XRD results.

(a)  $\rm ZrO_2$ -8 $\rm Y_2O_3/Ni$ -16Cr-6AI-0.31Y COATING SYSTEM AFTER 120 1-hour CYCLES, CROSSSECTION B, LEADING EDGE.

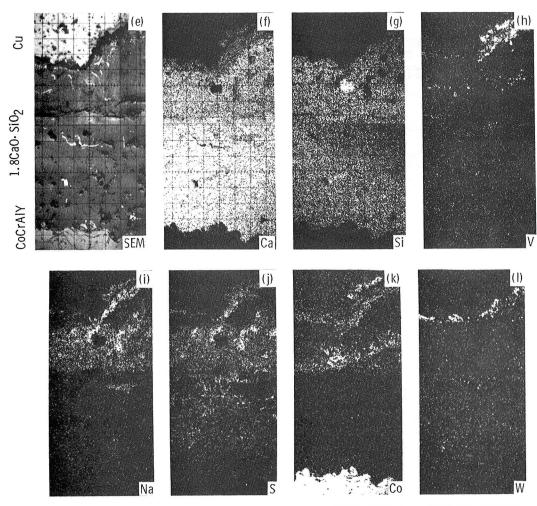
(b) 1.8CaO·  $\rm SiO_2/Co$ -22Cr-13AI-0.3Y COATING SYSTEM AFTER 620 1-hour CYCLES, CROSS-SECTION A, LEADING EDGE.
